UTC Incident Investigation Form

Notification ID:	3523	Investigation ID:	7974
-------------------------	------	--------------------------	------

Operator:	Tidewater Terminal Company
District/Unit:	Snake River Terminal
Location:	Pasco, WA
Incident Date:	6/2/19

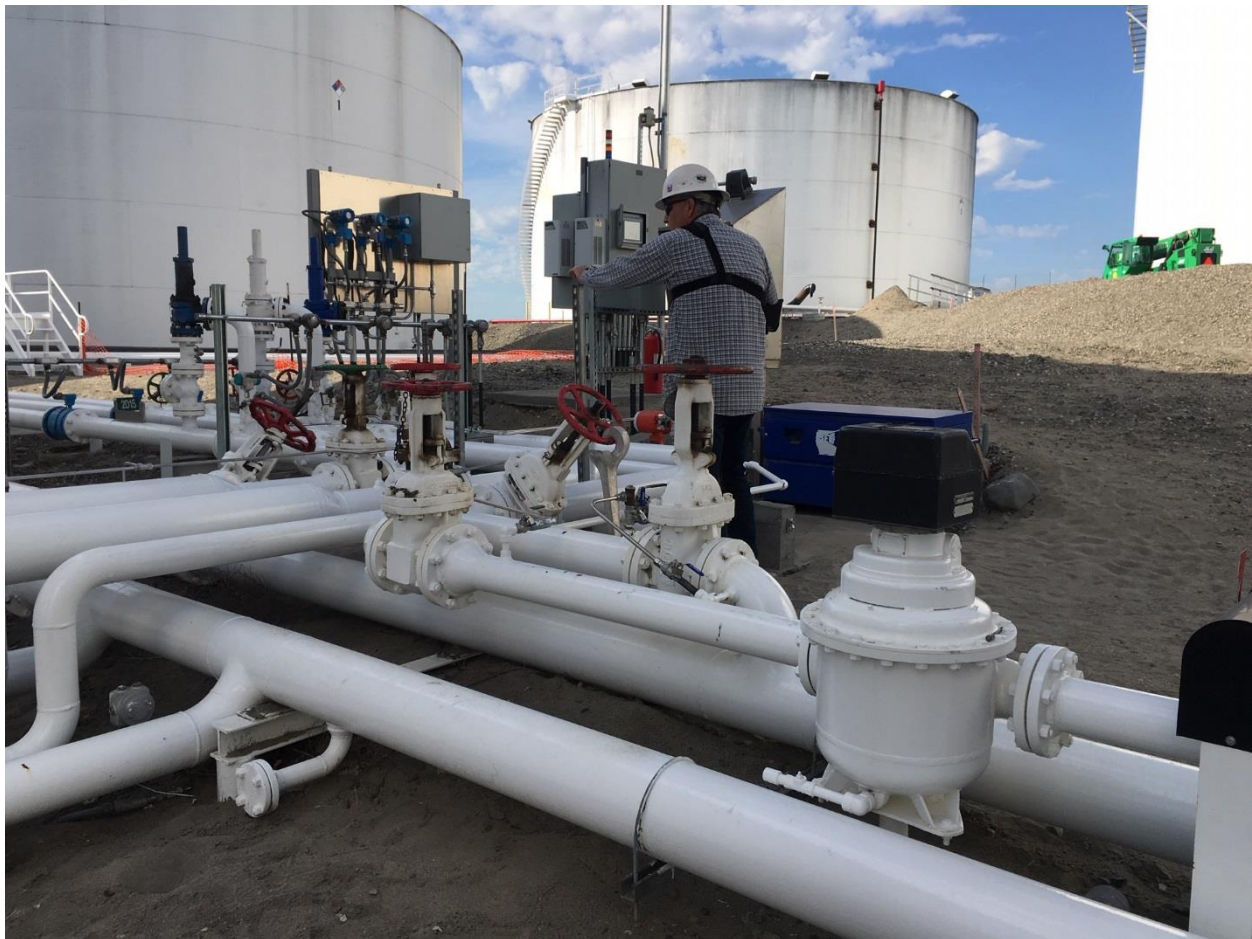
Figure 1 Location of SCADA Panel in Tank farm in relation to thermal relief on Tank 7 transmix line

16:30 approx. Employee Thomas then notices the thermal relief was in the closed position (Tank farm SCADA panel is immediately adjacent to this thermal relief). Employee Thomas opens the relief and it immediately starts relieving. To help relieve pressure in a timely manner, he also "cracked" the mainline block valve for a few minutes. After several minutes, he closes mainline block valve.

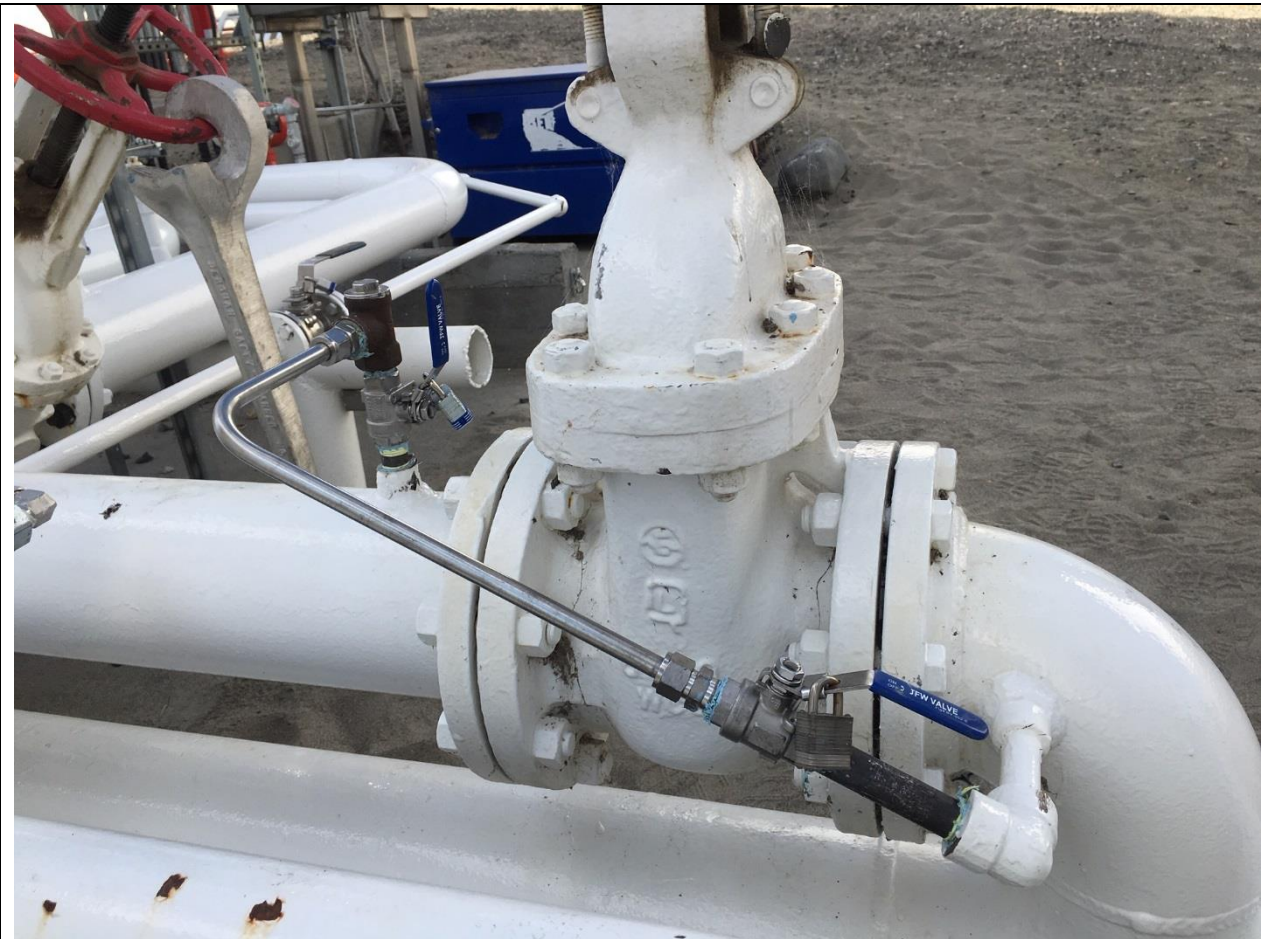
2:23-Approximately 10 minutes after receiving the initial batch of unleaded, employee Scott made the valve switch to send transmix into Tank 7. She also turned the thermal relief valve, which protects this portion of above ground piping, to the closed position. Since 2014 when Tidewater began accepting transmix, this protocol to turn off the thermal relief has been a "standard practice". The reason given by personnel as to why they close the relief valve is because sending product from the inbound gasoline line which is 6", to the transmix line, which is 4", increases the line pressure above the set point of the thermal relief which is 40 psi (can reach approximately 51 psi). When that happens, the valve opens and product is released into a half-inch pressure relief line. This line relieves around the block isolation valve into the unleaded inbound line. To prevent contaminating the unleaded gasoline with transmix, employees developed a work around--closing the thermal relief during receipt operations involving transmix.

Figure 2 Thermal relief on transmix line-shown locked open note-there was no lock previous to the incident.

- 2) Tidewater must immediately prepare and implement a procedure to ensure critical safety devices cannot be turned off during normal pipeline operations and further, define under what conditions and management authority they are allowed to be closed off. All personnel must be trained on the procedure.

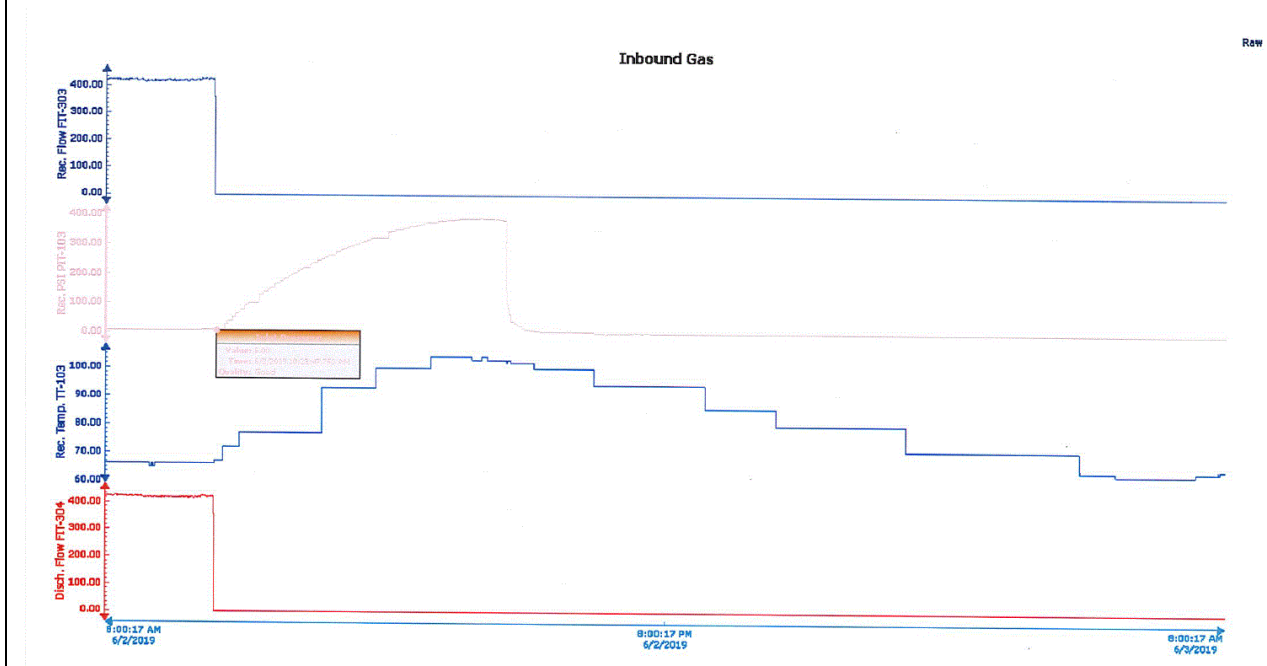
5:30-Employee Remus looks at trend logs prior to shift change and notices pressure spike from June 2, 2019. Spike was 384 psi. MOP of the line is 285 psi (basis on ANSI Class 150 flanges). Note: this exceeds 110% of the MOP and therefore is a safety related condition reportable to PHMSA per 49CFR 195.55.

Alarm time	Acknowledge time	Message
* 6/4/2019 7:39:58 AM	6/4/2019 12:43:09 PM	BARGE PIT ALARM
* 6/4/2019 7:35:32 AM	6/4/2019 12:43:09 PM	TANK 32 HIGH
* 6/4/2019 7:35:32 AM	6/4/2019 12:43:09 PM	TANK 32 HIGH HIGH
* 6/4/2019 7:29:43 AM	6/4/2019 12:43:09 PM	TANK 25 HIGH
* 6/3/2019 2:58:10 PM	6/3/2019 5:23:12 PM	INBOUND UNLEAD HIGH P ²
* 6/3/2019 2:56:31 PM	6/3/2019 5:23:11 PM	INBOUND UNLEAD HIGH P ²
* 6/3/2019 2:50:21 PM	6/3/2019 2:54:25 PM	INBOUND UNLEAD HIGH P ²
* 6/2/2019 3:35:46 PM	6/3/2019 4:12:48 PM	INBOUND UNLEAD HIGH P ²
* 6/2/2019 2:10:48 PM	6/3/2019 4:12:48 PM	INBOUND UNLEAD HIGH P ²
* 6/2/2019 2:50:39 AM	6/2/2019 2:57:27 AM	TANK 84 HIGH HIGH
* 6/2/2019 2:50:37 AM	6/2/2019 2:57:27 AM	TANK 84 HIGH
* 6/2/2019 2:50:22 AM	6/2/2019 2:57:27 AM	TANK 85 HIGH
* 6/2/2019 2:50:22 AM	6/2/2019 2:57:27 AM	TANK 85 HIGH HIGH

Figure 5 Alarm log and pressure graph

- 4) Tidewater must immediately fix/repair the SCADA computer logic at the Barge office to ensure alarms are properly displayed and logged to ensure proper response by Tidewater personnel. All personnel must be trained on the changes to the system. Additionally, the historian time log of events must be correct and therefore the actual time must be correct in the SCADA logic.
- 5) Tidewater must review, with all operators, the current procedures for responding to abnormal operating conditions (including alarms) and the appropriate response expected by Tidewater management. All necessary changes must be documented and employees trained accordingly.
- 6) Per 49 CFR 195.428, Tidewater must immediately inspect PSV 1 (and any other thermal relief with deficient documentation) and any defective device must be repaired or replaced. All inspections must be documented appropriately.
